Technical Bulletin

TB#: 0603-1

Date: April 25, 2006

MODEL NUMBER : VX-1700

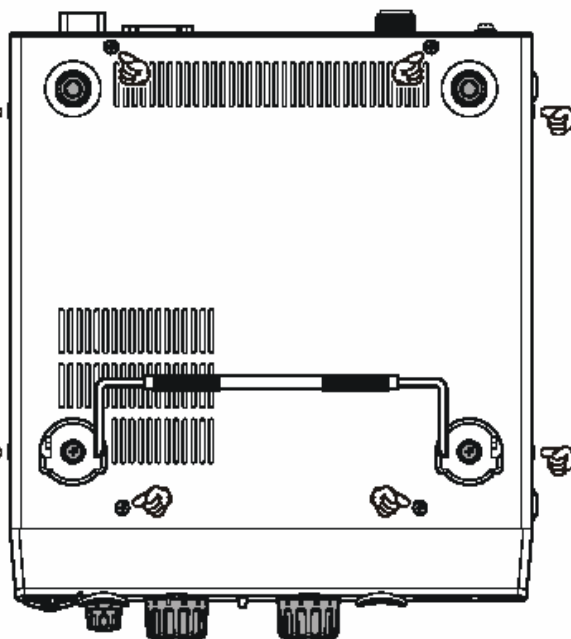
Locate the switch S1001 located next to the cooling fan. Move Switch 3 to the **ON** position.

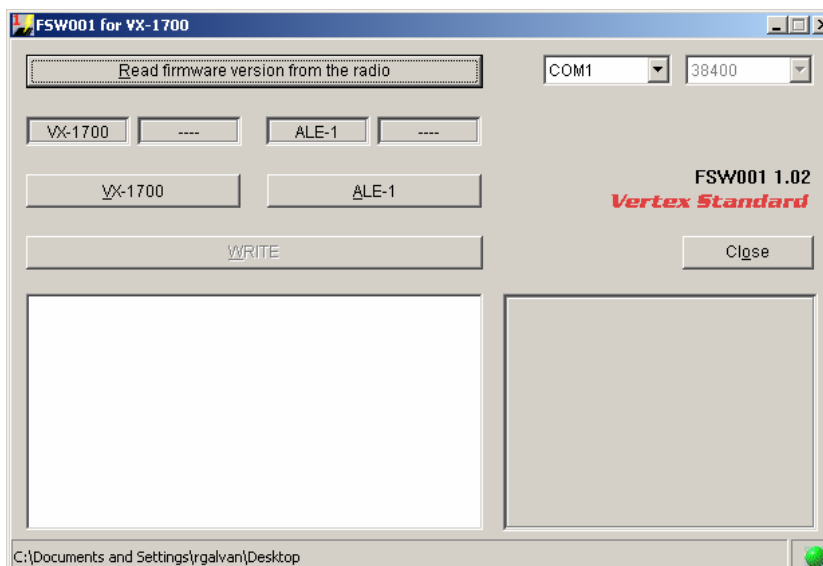
Unzip the file FSW001VER 1_02_USA and start "FSW001.exe". The following program starts.

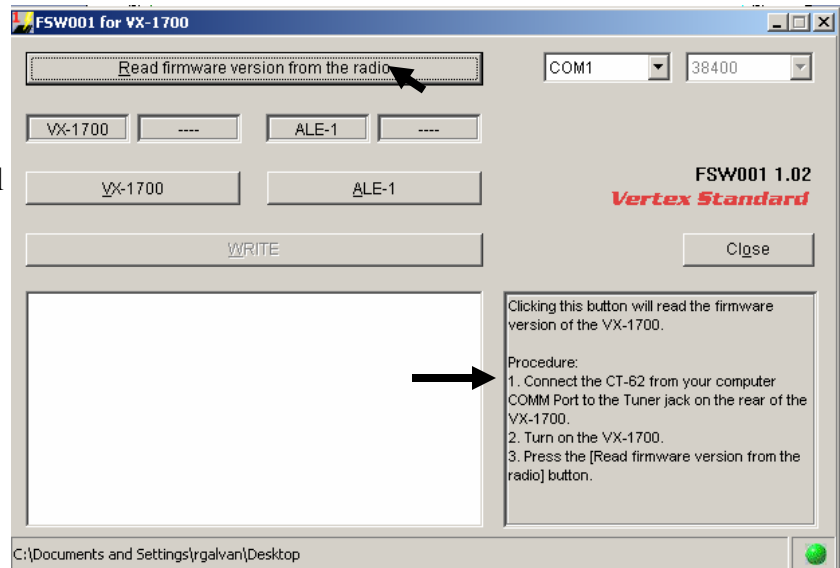
Here you can read the firmware version from the radio by press this button. You will need the normal programming cable (CT-62) for this.

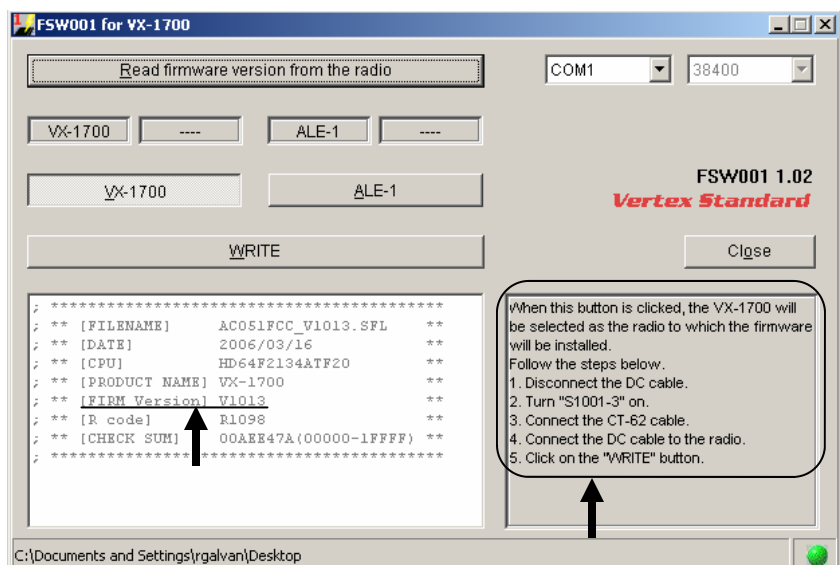
For our purpose, we will send new firmware to the radio. Press the VX-1700 button to load the new firmware (verify version V1013).

Also, this will show the update procedure in the window to the right.

Once the update process begins, the instructions on the right will be replaced with dual progress bars. When the progress bars are finished, the update process is complete. When finished, an 'OK?' window will appear. Click ok to finish and exit. Make sure to move S1001-3 back to the off position and re-assemble the radio.
