The first steps to cure your Icom IC-7100 shut down problem

By Tallman

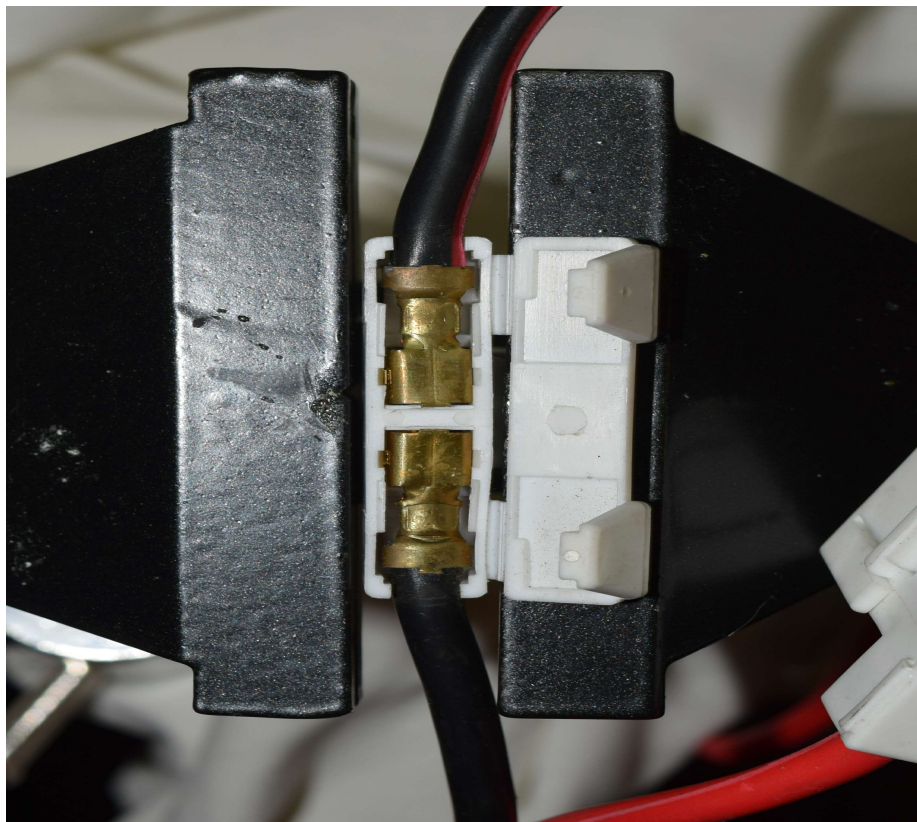
When I checked the voltage on my test bench the voltage it was dropping down to 11.3 volt and I have a 50 amp Megawatt power supply so there was plenty of current available. I was going just to fix this problem. I opened the back of the fuse holders and pried the connector clips out of case and inspected them under 20x microscope. The color did not look right and showed some indications of heating.

This indicated to me that there was a resistance between the wire and connector clip. I did not have replacement parts available and ended up soldering the existing connectors as they were. I don't like soldering wires where the solder and melting insulation will mix, but at this point I really did not have a choice. I soldered all four connectors and reassembled for more testing.

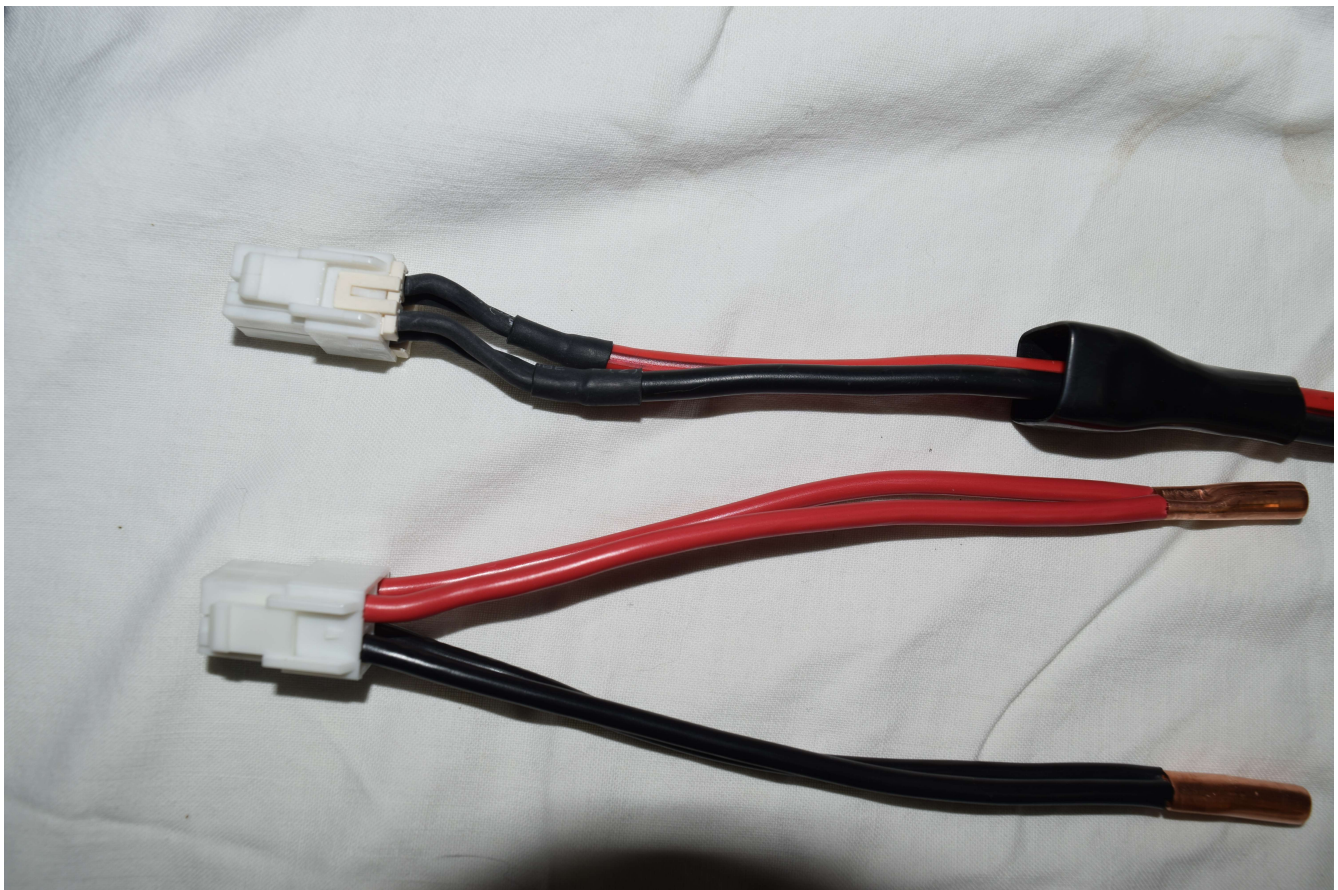
Here is photo of that portion of the repair, the copper tubing is 1/4" used instead of the insulated crimp connectors. You can't solder insulated connectors, tinning is advised before making connections. It might be a little over kill, but I like it that way. The 12 ga. wire was soldered into the pins before insertion the connector body.

To finalize the connections after soldering I covered the copper tubing with two layers of thick heat shrink tubing on each connection and a layer of PVC electrical tape not pretty but it works.

I retested and the voltage only dropped .5 volts. I gained two volts at the connector and three watts of RF output.
