browning®

SERVICE
NOTES

SN 80131

GOLDEN EAGLE MARK IV

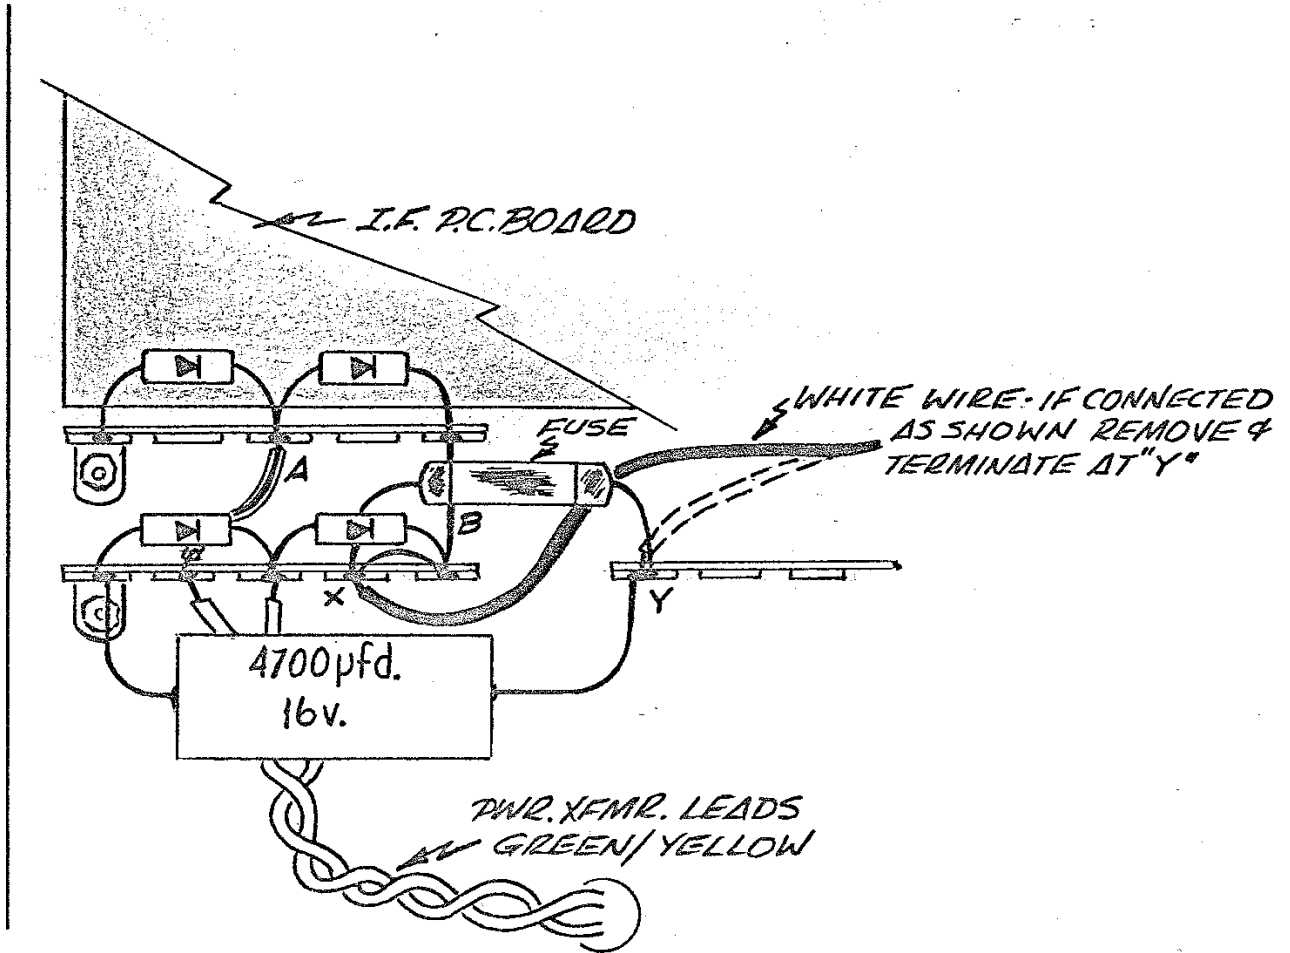
GOLDEN EAGLE MK IV
RECEIVER

PROBLEM: Failure of the +11 V. Rectifier Bridge D3
(PD1011 or PD1560) due to high initial surge
current.

SOLUTION: Replace the bridge with four individual
3A. 400 P.I.V. diodes.
(Refer to attached diagram.)
Some sets may not have the 3A. fuse and some
have two 2200 MFD capacitors instead of the
4700 MFD.

CAUTION! Do not use these diodes to replace the high
voltage supply as these must be 1000 P.I.V.
or greater.

- 1 S/N 6-0019 TERMINAL STRIP 5-H4A
- 4 S/N 7-0131 DIODE, 3A. 400P.I.V.

FOR JUMPERS "A" & "B" USE
20 BUSS WIRE WITH PLASTIC
SLEEVING OVER "A"
