AMSTRAD 900,901
MUSTANG 1000,2000,3000
HARVARD 402, 407, H646
SPINNEYTRONIC CB199
FIDELITY 2001
NATO 40FM
TRANSCOM

AMSTRAD

COLIN HINSON (G3LNU)
EMAIL: CHinson@Bham.ac.uk
WEB: www.cbtricks.com
D AMSTRAD.SCH
Date: Monday, February 27, 2011 Page: 6 of 9

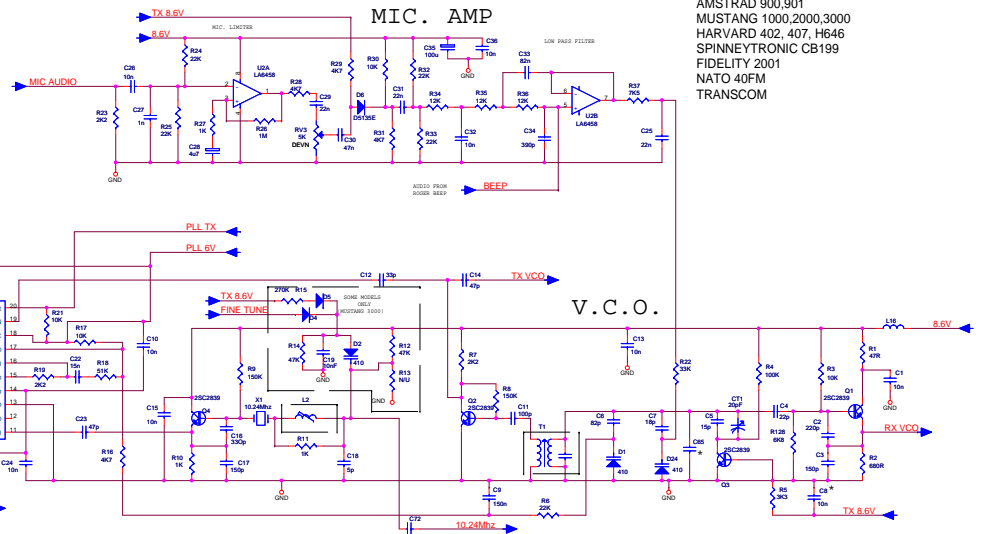
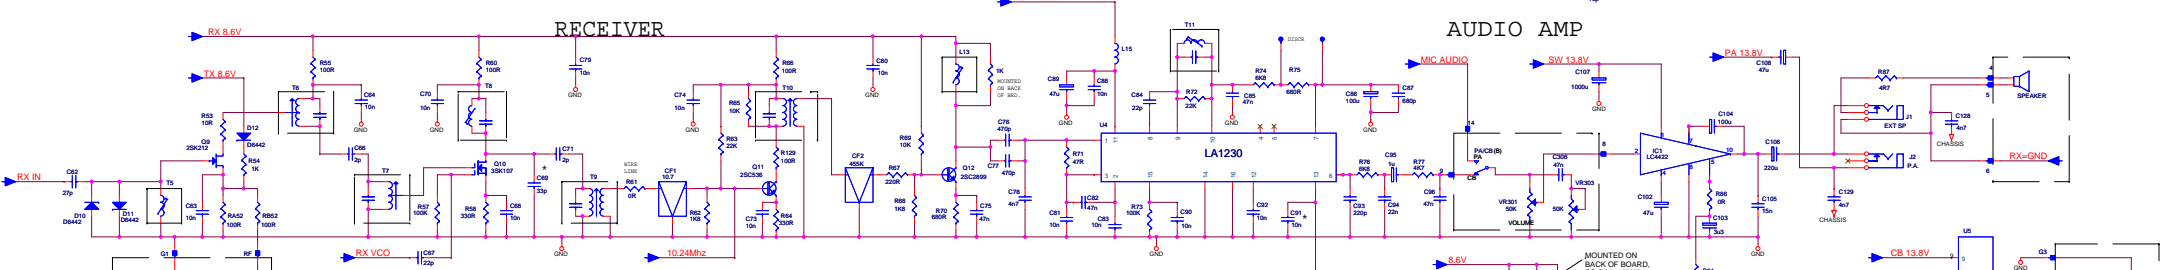
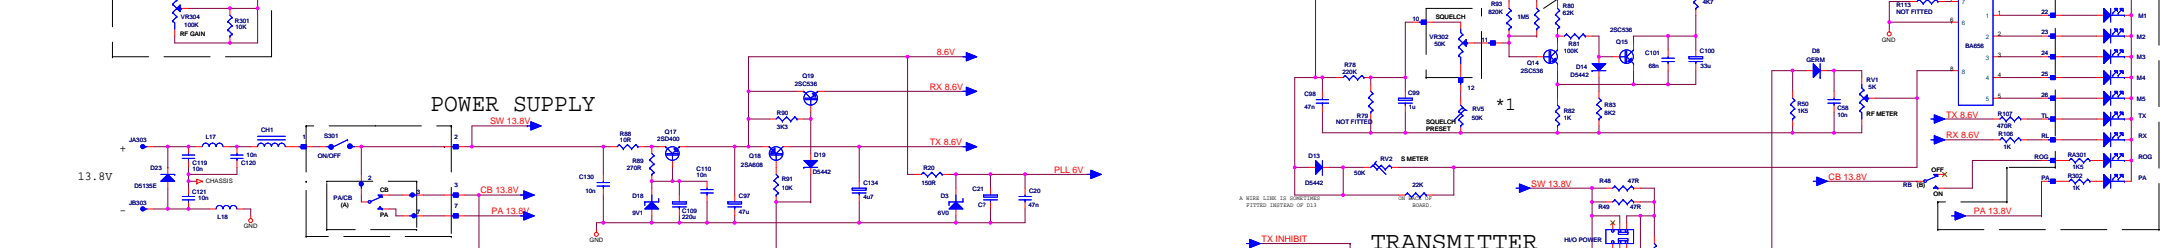
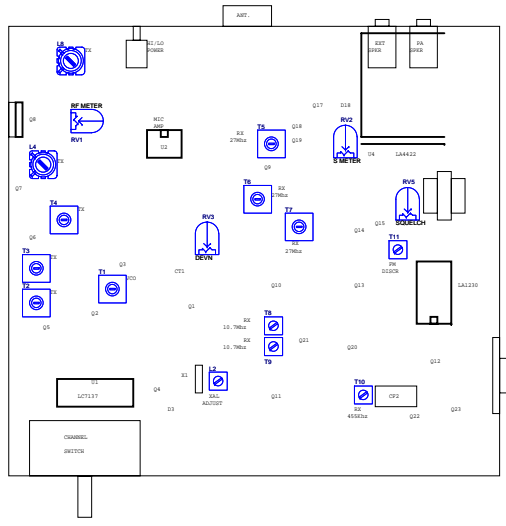
THIS DIAGRAM IS AN ATTEMPT TO MAKE THE CIRCUIT EASIER TO FOLLOW THAN THE ORIGINAL. OF NECESSITY THIS MEANS THAT THE FRONT AND REAR PANEL COMPONENTS ARE NOT DRAWN TOGETHER (AS ON THE ORIGINAL) BUT ARE DRAWN WHERE REQUIRED - I'M SURE YOU CAN FIGURE OUT WHERE THEY ARE :-) THE POWER SUPPLY SECTION ON THE ORIGINAL WAS DREADFUL, AND HOPEFULLY IS NOW DRAWN SO THAT IT IS EASILY UNDERSTANDABLE. ANY SUGGESTIONS FOR IMPROVEMENTS OR CORRECTIONS OF ERRORS SHOULD BE ADDRESSED TO ME AT THE EMAIL ADDRESS GIVEN IN THE TITLE BLOCK AT THE BOTTOM RIGHT HAND CORNER.

- NOTES:**
- *1 ON EARLY CHASSIS, 47K IS IN SERIES WITH RV5 (SQUELCH PRESET). THIS SHOULD BE SHORTED OUT TO GET BETTER SQUELCH ACTION
 - *2 ON CHASSIS WITH METERS (MUSTANGS, TRANSCOM etc), D13 IS FITTED IN PLACE OF THE WIRE LINK NEXT TO T11. THESE RADIOS REALLY NEED AT LEAST ONE MORE DIODE IN SERIES IN ORDER TO REDUCE THE READING ON THE METER TO ZERO FOR NO SIGNAL INPUT.

EVIL FAULT:
TX AND RX LIGHTS ON TOGETHER: Q22 LEAKY
